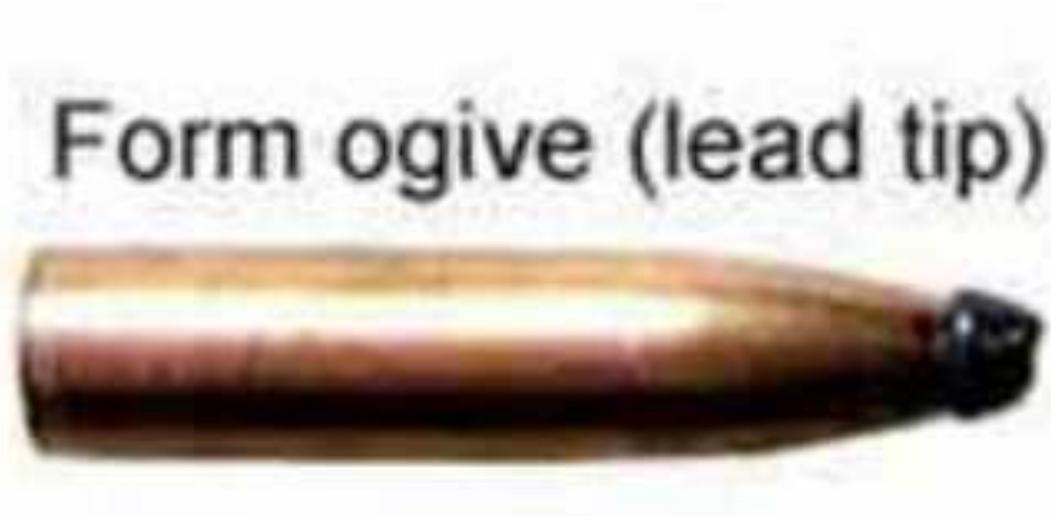
The picture below shows the lead core being squeezed out of the tip under extreme swaging pressures. Copper is also flowing to one side of the lead core more than the other during this tip forming stage.

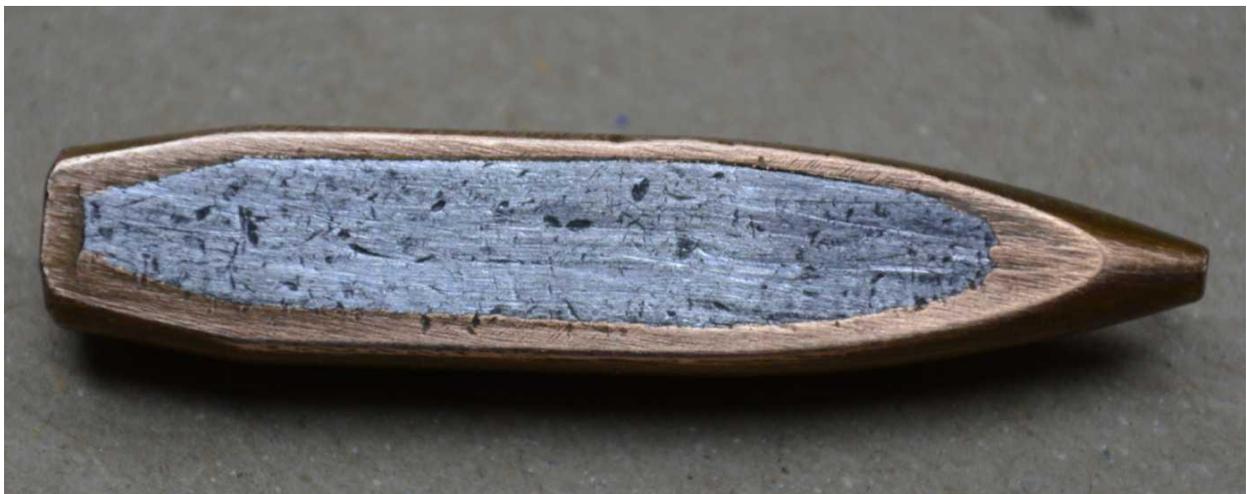
The picture below is a bullet that was sectioned to show the result of these extreme pressures. The copper jacket on the bottom is almost two times as thick as the top. You can measure the jackets before the tip forming process with measuring instruments that can measure to a ten thousandth of an inch. After the tip is formed this type of jacket variation becomes hidden and this is what the Vern Juenke machine was designed to detect. The bullet manufactures have tried their best to control the quality of the components that they use in bullet making. But somehow we still get bullets like these in the box.
